Home Inspection Report

2476 Poplar Dr, Charlottesville, VA 22903

Thursday April 26, 2018

6918

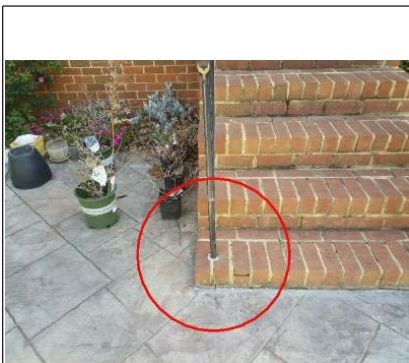
The loose brick and railing on the the back steps needs to be repaired by a licensed mason or qualified contractor.

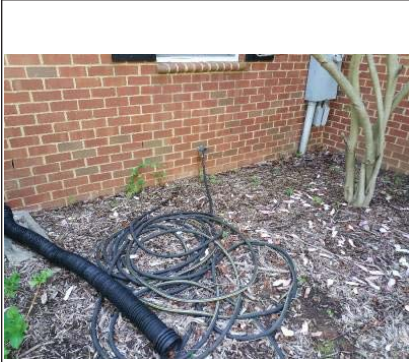
The soil grade in the front right corner of the home needs to be corrected to prevent future moisture penetration into the basement.

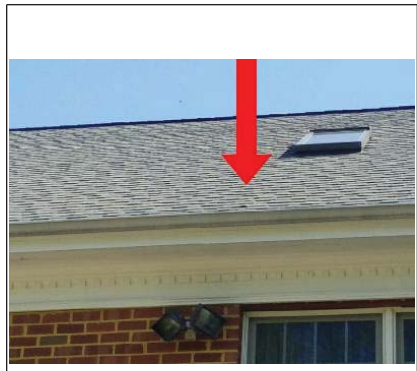
Recommend having a qualified contractor repair the nail pop on the back roof section.

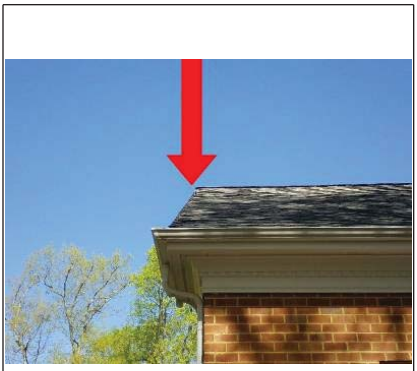
The nail pops on the garage need to be repaired by a qualified contractor.

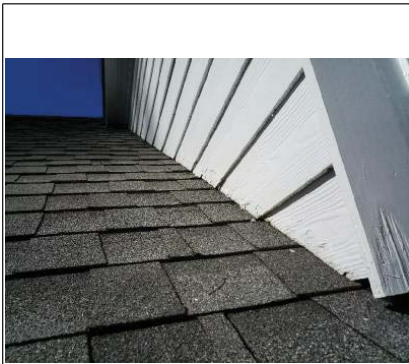
The damaged siding on the far right dormer needs to be replaced by a qualified contractor. There should atleast one inch of spacing between the roof shingles and siding to prevent future moisture damage.

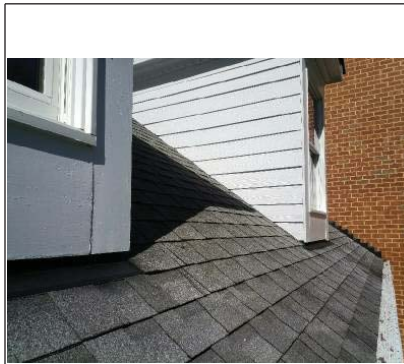
Recommend having a qualified contractor trim at least one inch from the corners to creat separation from the shingles and prevent future moisture damage.

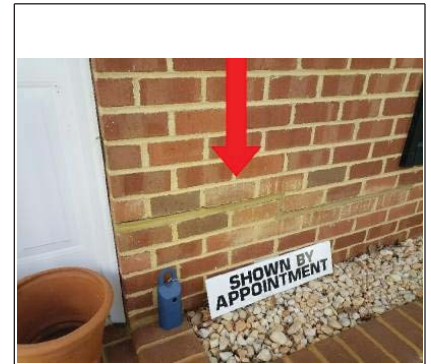
There is evidence of movement in the front brick veneer, recommend having a licensed mason evaluate and repair as needed.

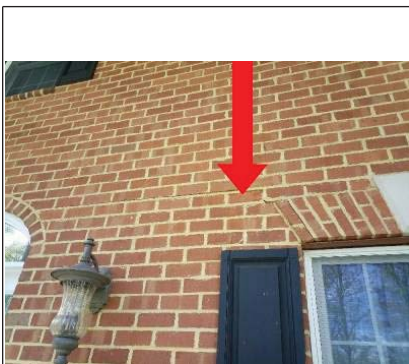
The cracks above the front windows in the brick veneer need to be repaired by a licensed mason.

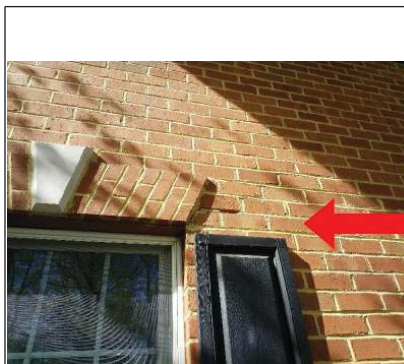
Cracks above the front window in the brick veneer.

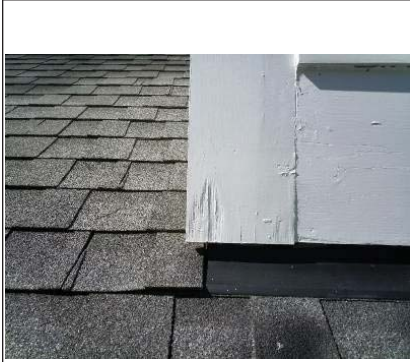
The damaged wood trim on all of the dormers needs to be replaced by a qualified contractor.

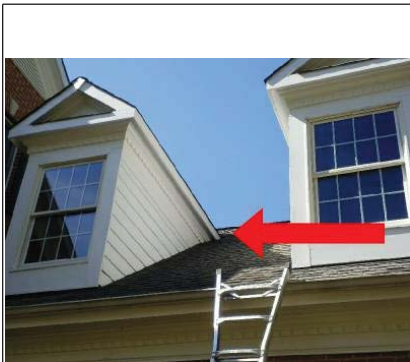
All of the damaged fascia on the dormers needs to be replaced by a qualified contractor.

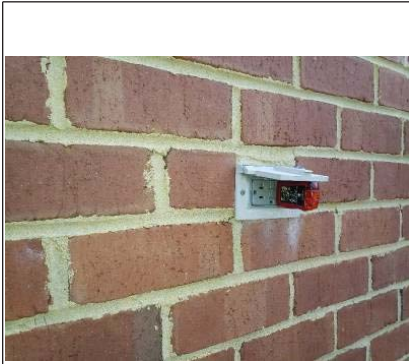
The GFCI receptacle above the patio needs to be wired correctly by a licensed electrician.

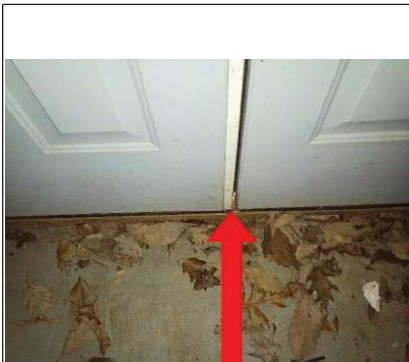
The basement door needs new weather stripping installed.

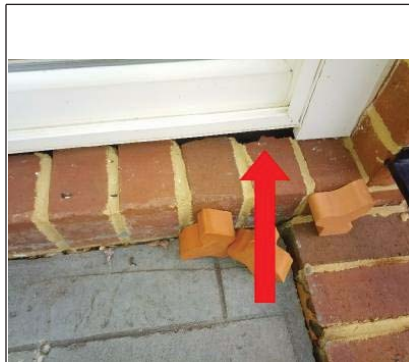
The void below the master bedroom sliding glass door needs to be sealed by a qualified contractor.

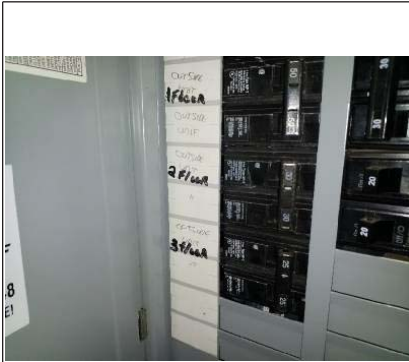
Two of the outdoor HVAC condenser units call for no more than a 25 amp circuit breaker and only have service disconnects installed, the 30 amp circuit breaker installed in the electrical panel is oversized for one of the units and needs to be replaced by a licensed electrician.

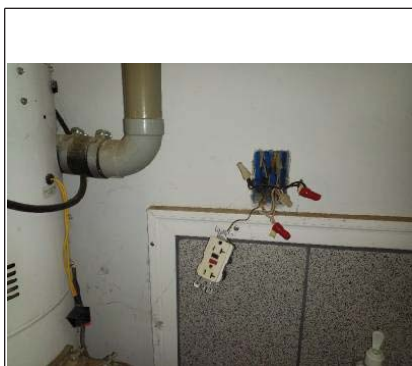
The garage GFCI receptacle needs to be repaired by a licensed electrician, the central vacuum system could not be tested due to the inoperable receptacle.

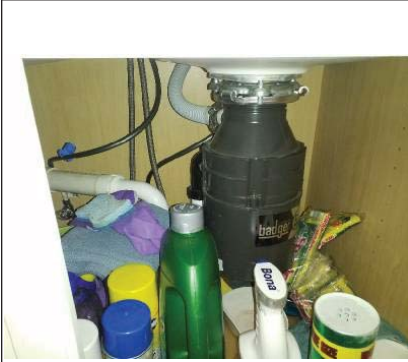
The kitchen sink disposal is not operational, recommend having a licensed plumber repair or replace as needed.

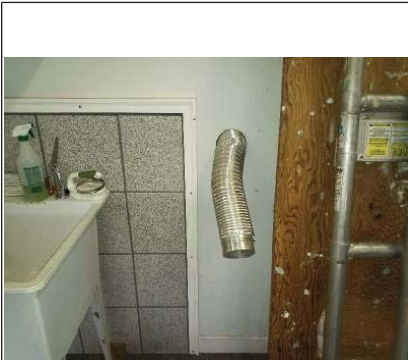
The clothes dryer needs to be vented to the exterior of the home.

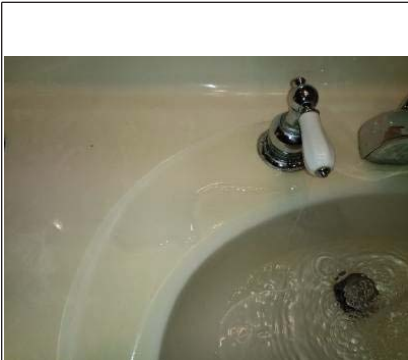
The second floor bath faucet leaks onto the counter and into the cabinet, recommend having a licensed plumber repair as needed.

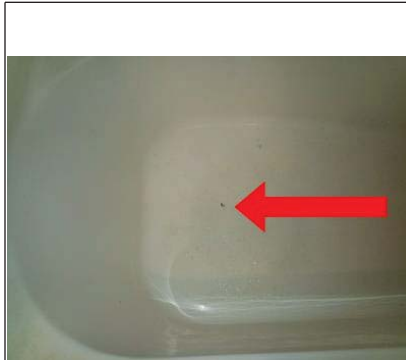
Recommend having a qualified contractor repair the damaged second floor bathtub.

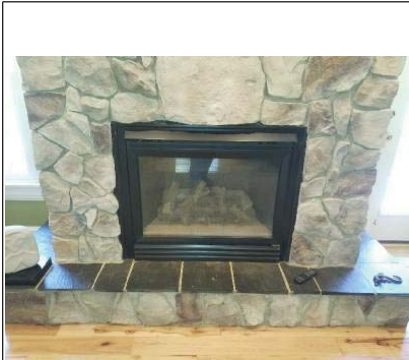
The gas fireplace is due to be cleaned, started, and tested for proper operation by the fuel provider.

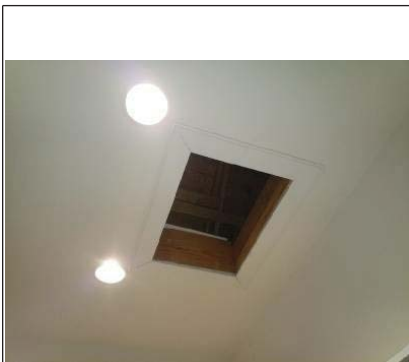
Recommend installing insulation over all of the attic access panels to prevent drafts.

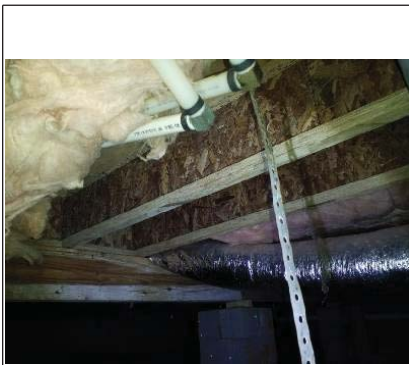
The missing basement crawlspace insulation need to be replaced by a qualified contractor.

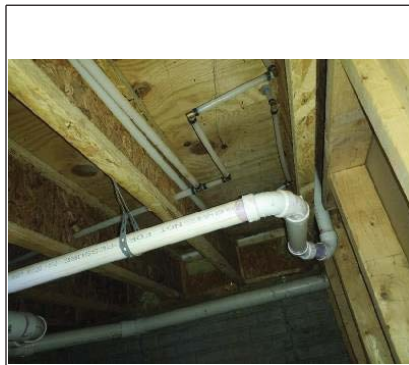
The missing garage crawlspace insulation needs to be installed by a qualified contractor.

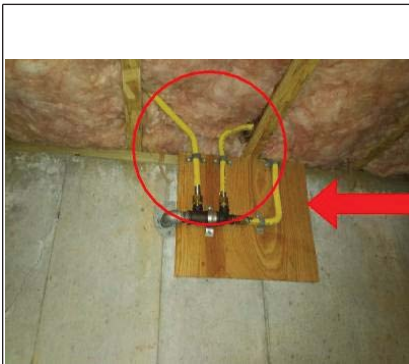
The continuous stainless steel tubing needs to be bonded by a licensed electrician due to the fact that stray voltage can create pin holes in the product, recommend repair.

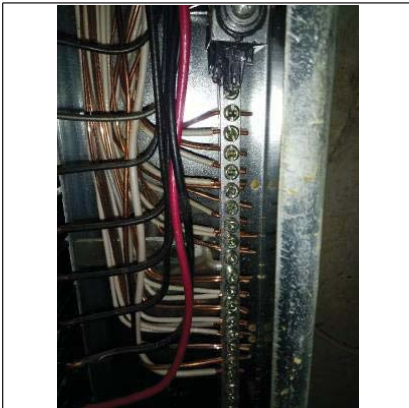
Double tapping of the neutral electrical panel bus bar is not permitted, recommend having a licensed electrician repair the double tapping in both of the electrical panles.
